# Boston's Open Space

1987  
PARK EVALUATION  
&  
SITE SUMMARIES

EVALUATION OF  
CITY OF BOSTON  
PARK AND RECREATION LAND

NEIGHBORHOOD OF BACK BAY/BEACON HILL

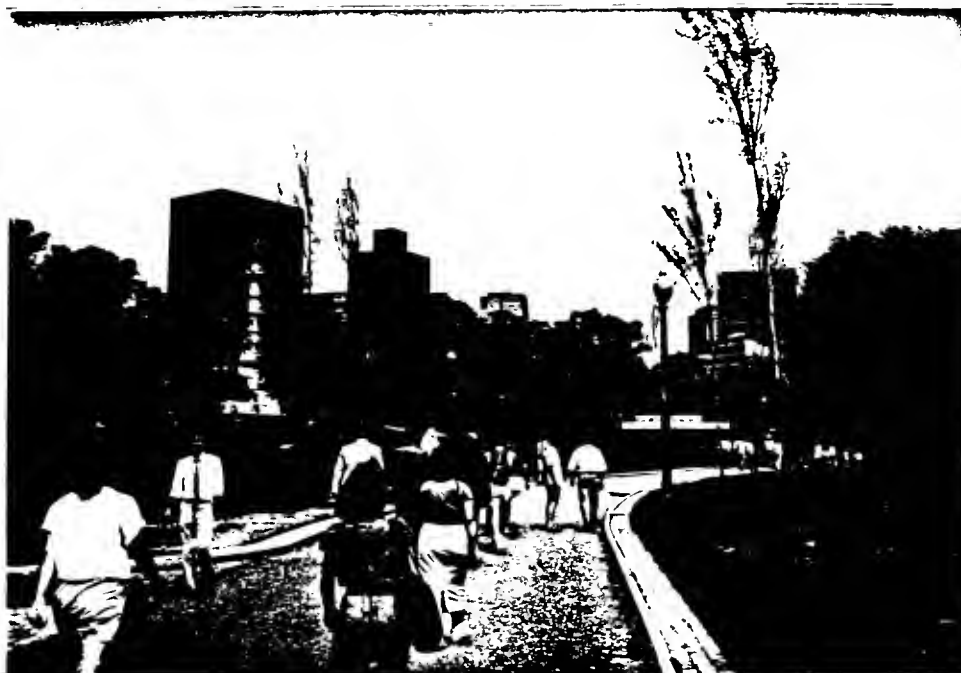
**Site Photograph 1**

From main entrance  
opposite Public Gardens.  
New tree planting doing  
poorly.

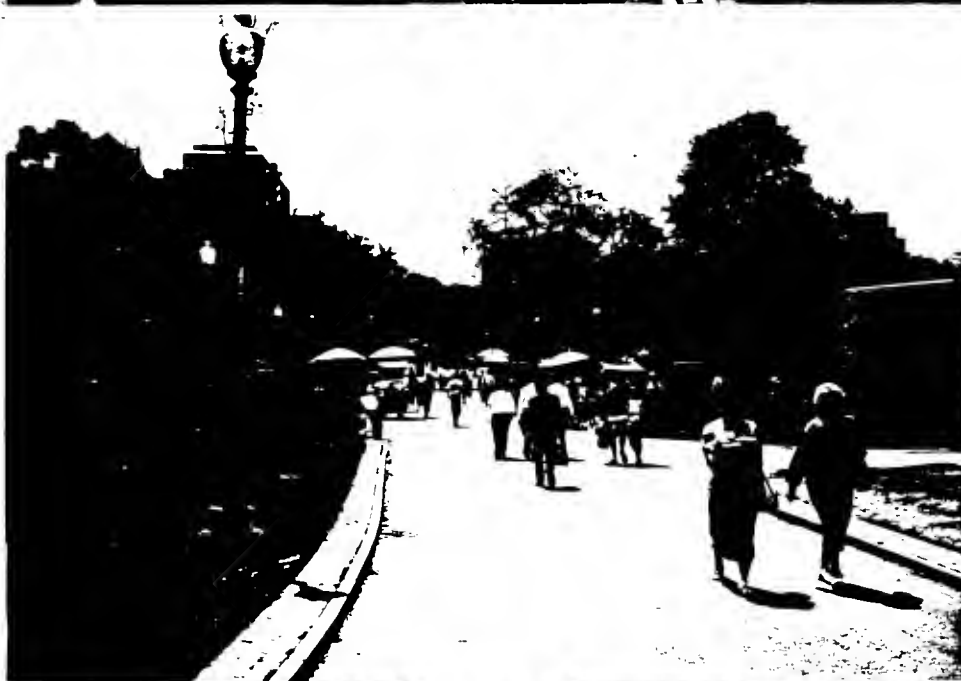
**Site Photograph 2**

Looking back at  
entrance. Entry  
dominated by street  
vendors.

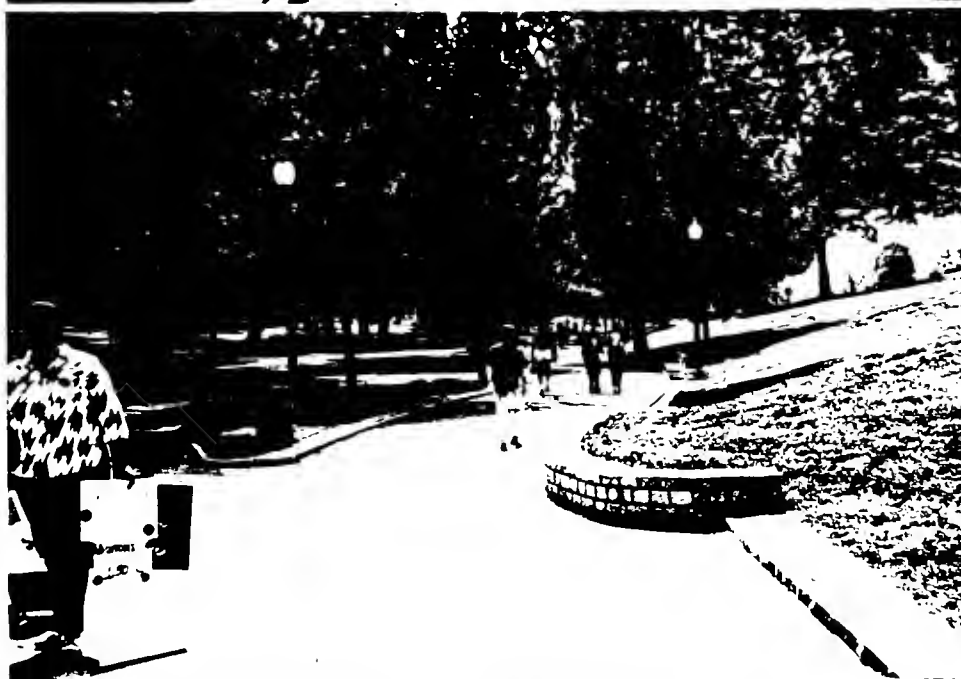
**Site Photograph 3**

Granite cobble edging  
installed to prevent  
areas of eroded grass.

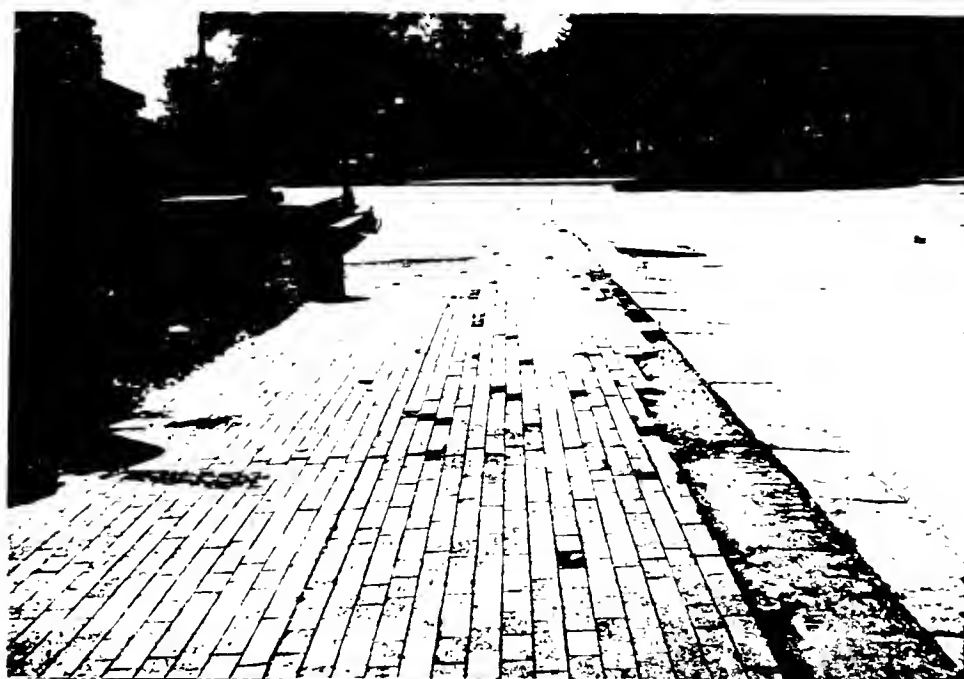
**Site Photograph 13**

Pavement needs repair.

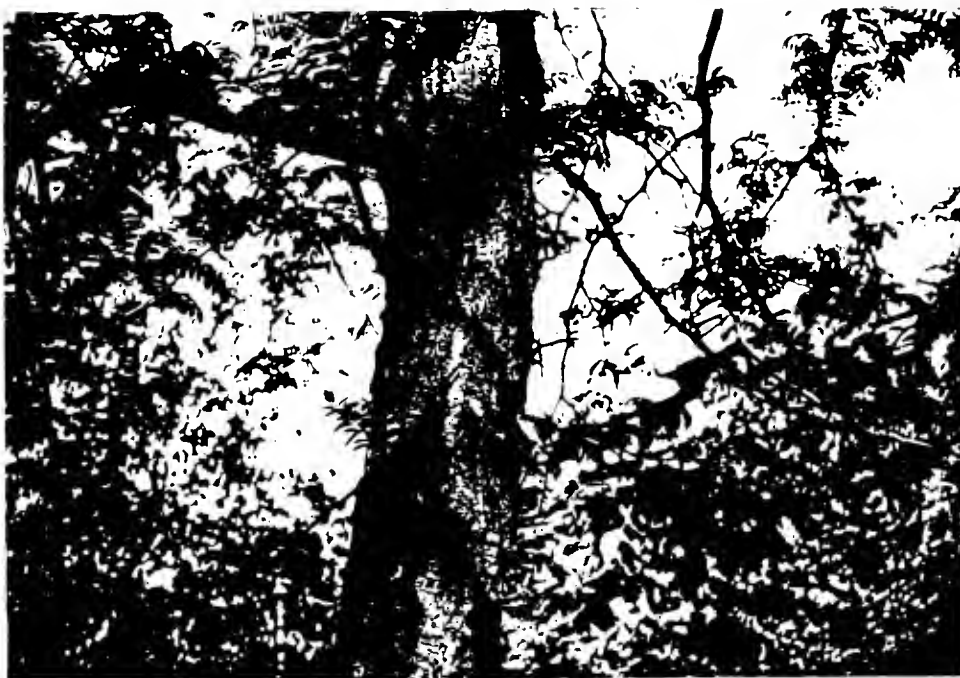
#### Site Photograph 6

Honeylocust developing  
thorns. Should be  
removed from trunk and  
lower limbs to be  
removed as necessary.

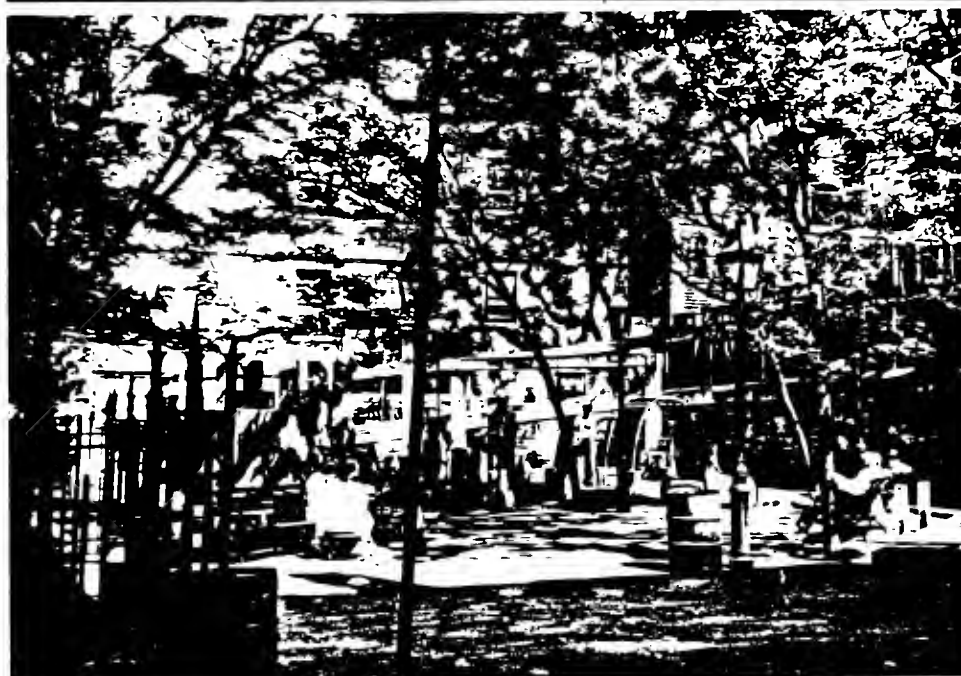
**Site Photograph 3**

Play equipment in far corner with seating areas in foreground. Gas lamps an easy target for vandals.

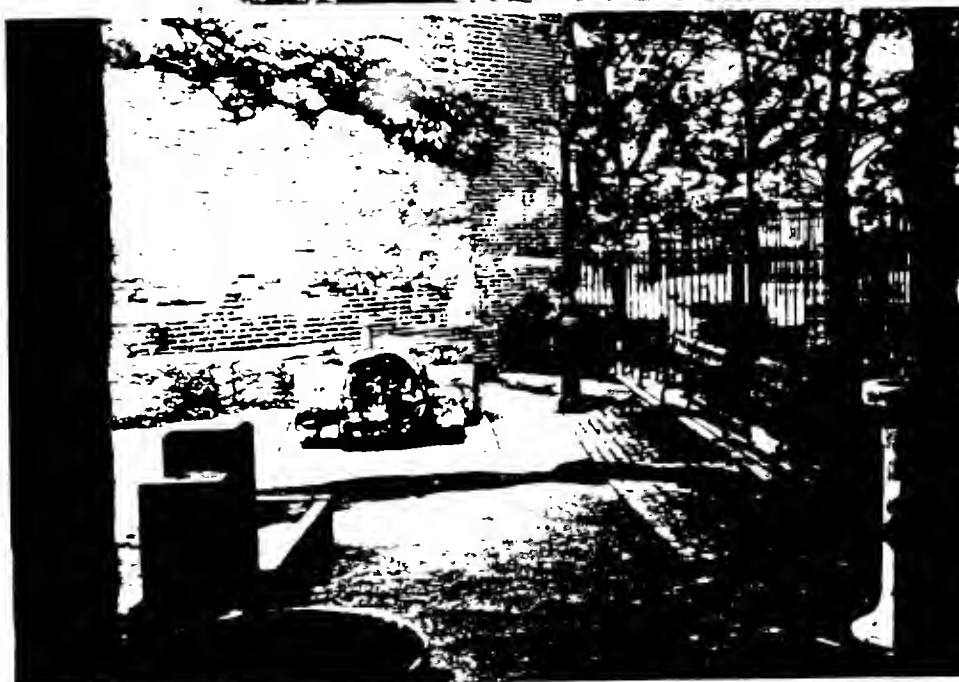
### Site Photograph 2

Upper level sitting area and broken spray equipment.

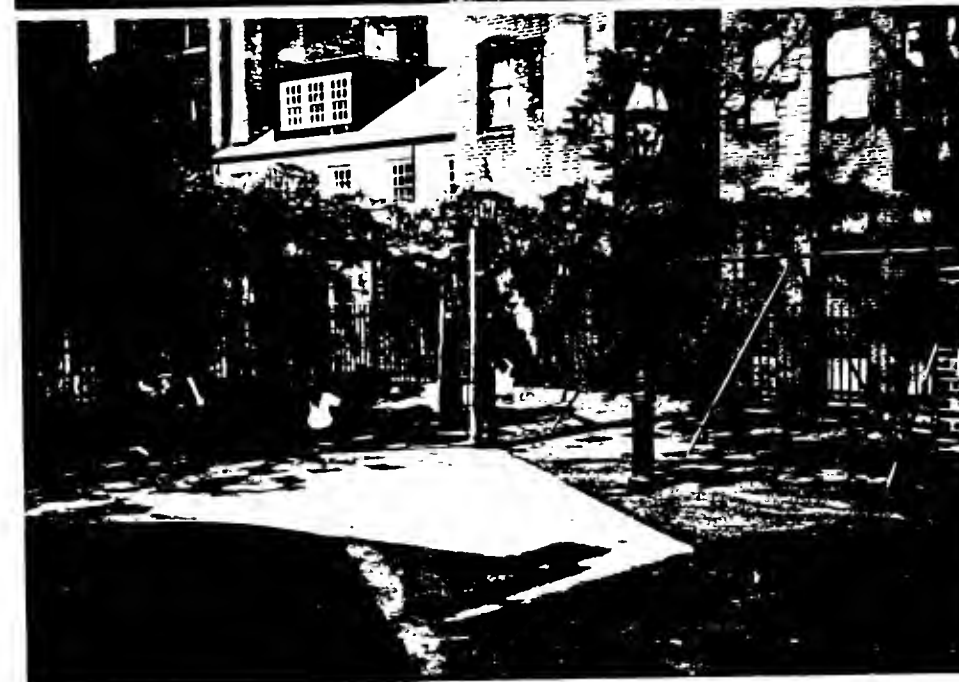
### Site Photograph 3

Lower level play equipment, tire swings unusable. Benches needed in far corner.

Most standard-park built elements are in good condition except for some gas lamps which are in fair or poor condition because the glass has been broken. The paving is generally in good condition as are the trees, shrubs and groundcovers. The play structures are mostly in fair to good condition, except for a few which are in poor condition. A tire swing is missing and needs replacement.

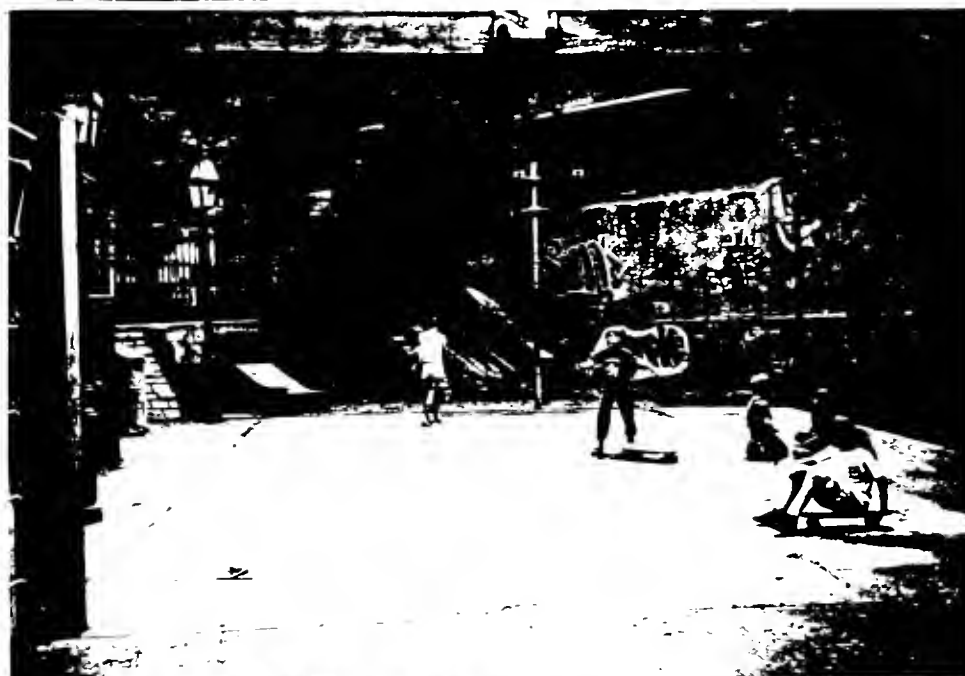
**Site Photograph 5**

Basketball area with  
no backboard. Slides  
and climbing equipment  
built up against  
terrace wall.

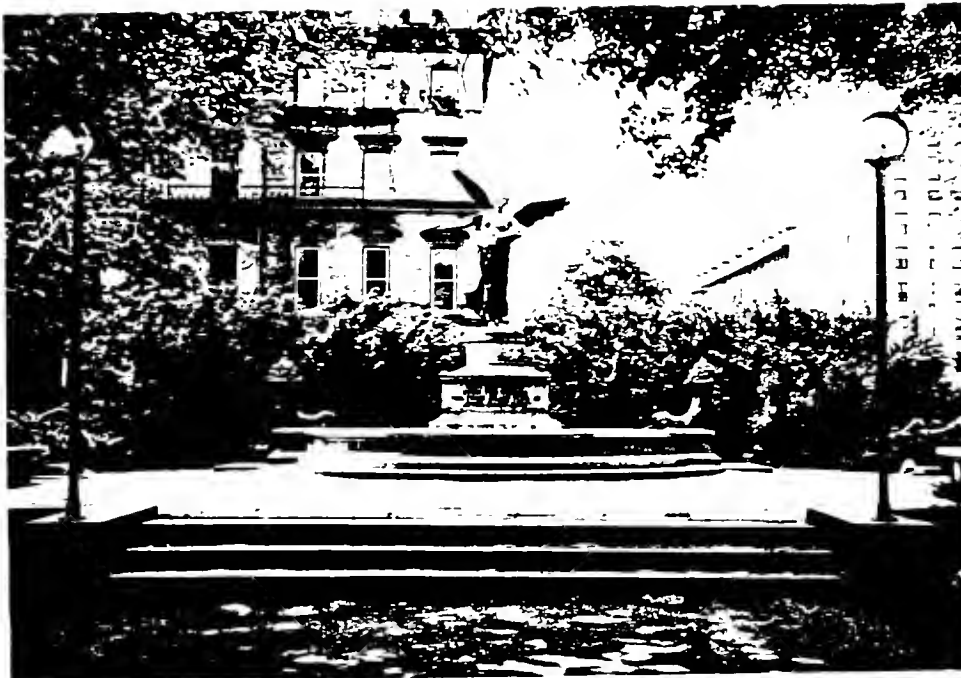
**Site Photograph 4**

Fountain-- not working.

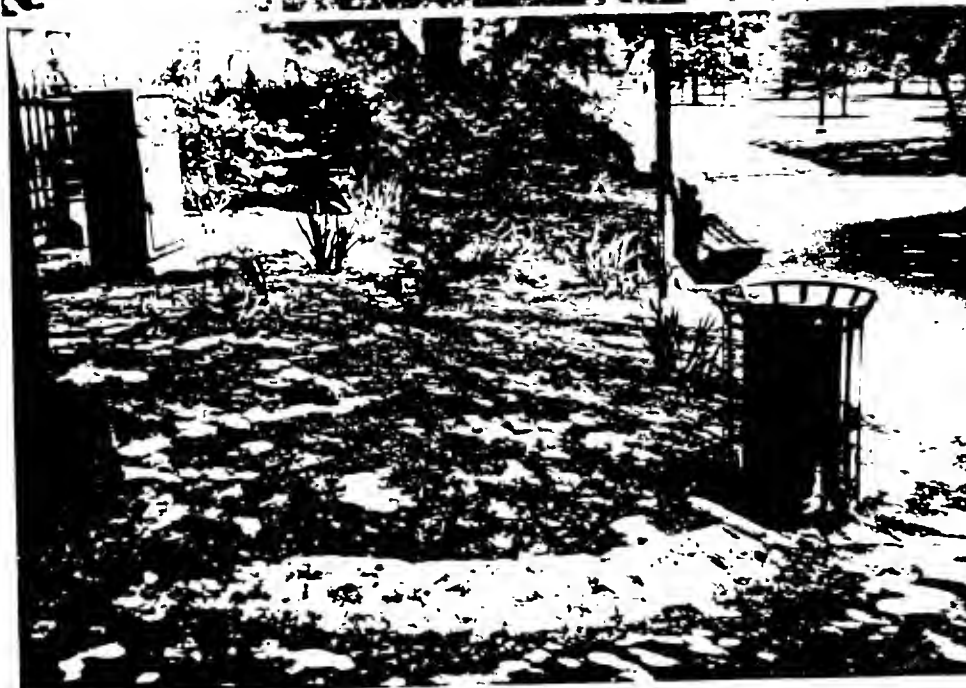
**Site Photograph 6**

A plant bed that is underplanted.

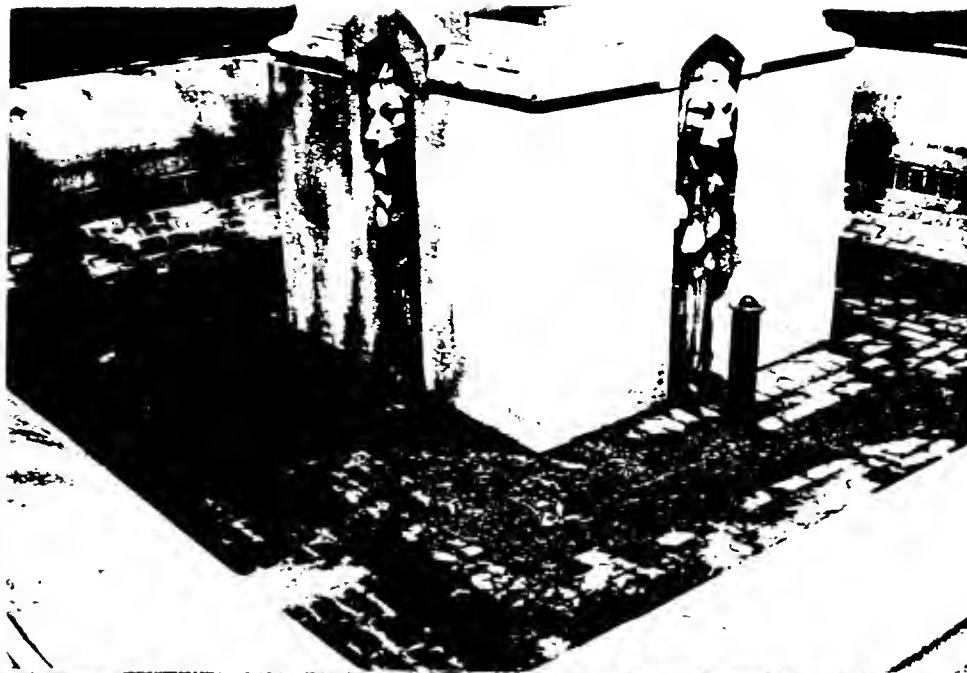
Site Photograph 7

A fountain-- not working.

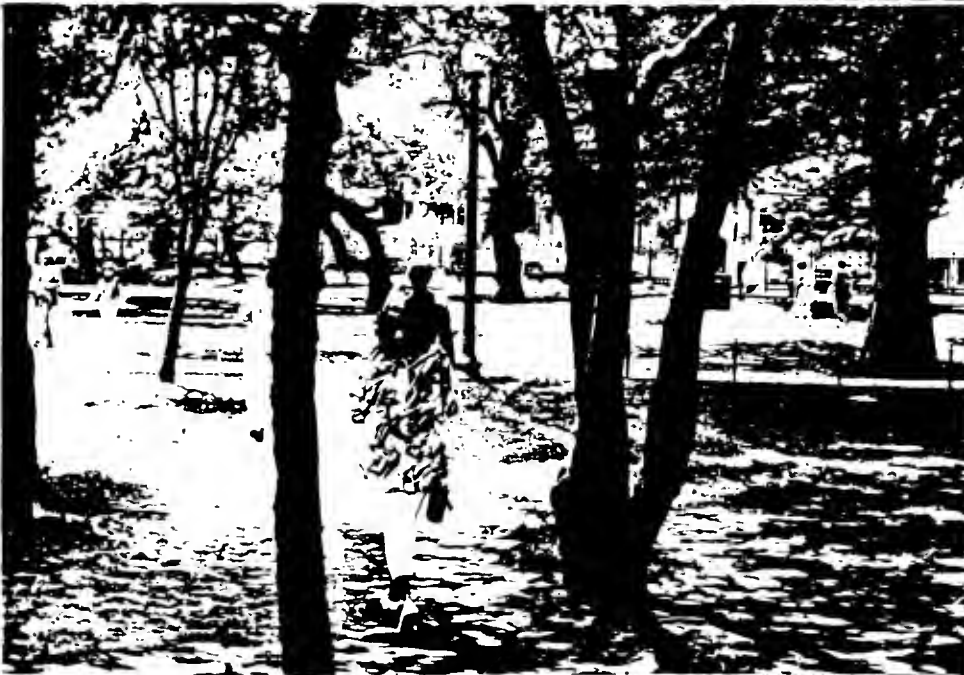
### Site Photograph 12

Trash build up around  
trash barrels.

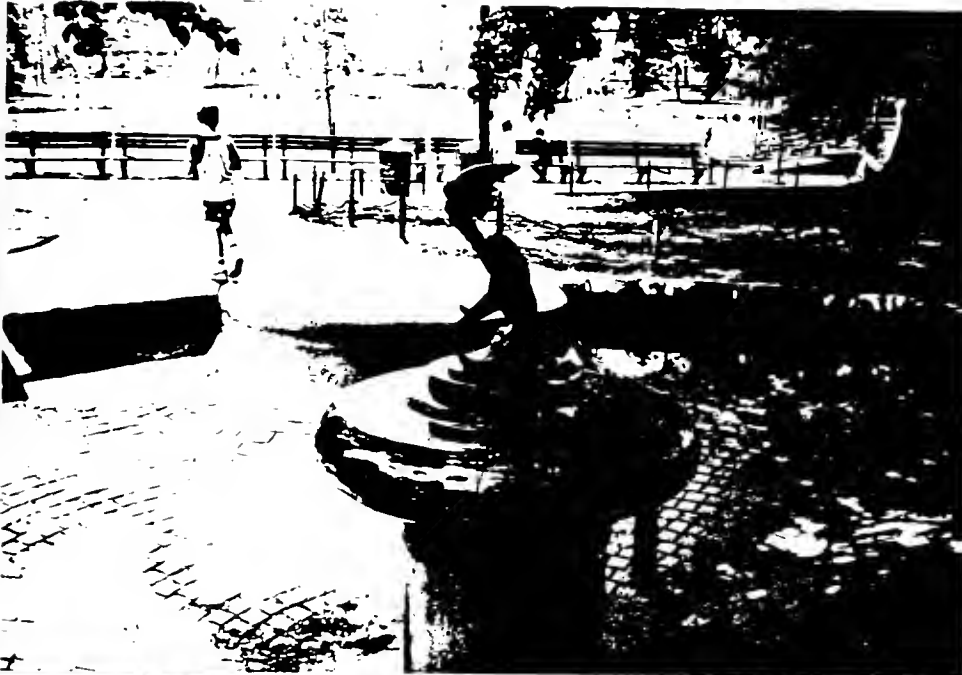
**Site Photograph 13**

Fountain-- not working.

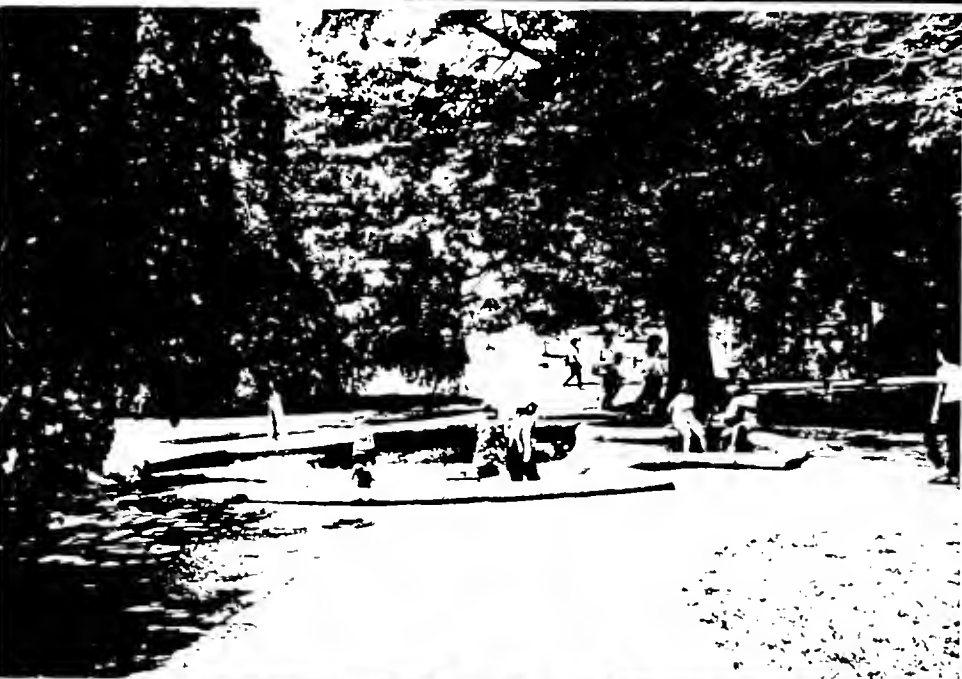
**Site Photograph 14**

Fountain-- not working.

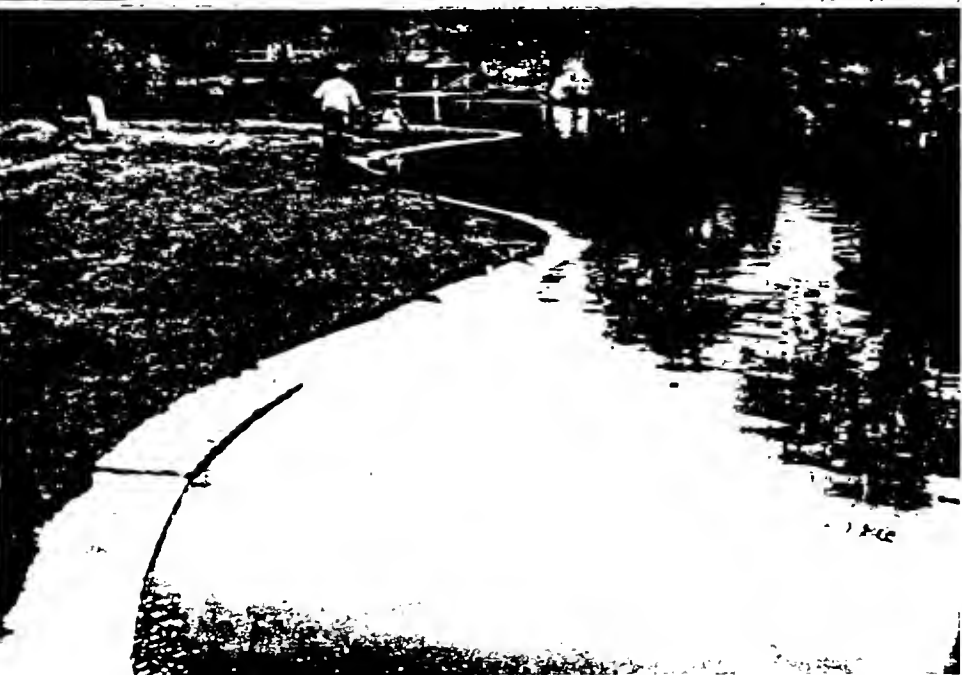
**Site Photograph 15**Edging around pond  
settling in some areas.

On the whole, maintenance is very good, with the exception that trash needs more frequent removal from receptacles. The edging around the pond has settled in places and needs repair. Fountains are all in need of repair, and would add immeasurably to the park if in operation. The heavy use of the site is evident in desire lines and worn patches in the grass. Compacted dirt around trees will cause stress by denying water and oxygen intake of the roots.

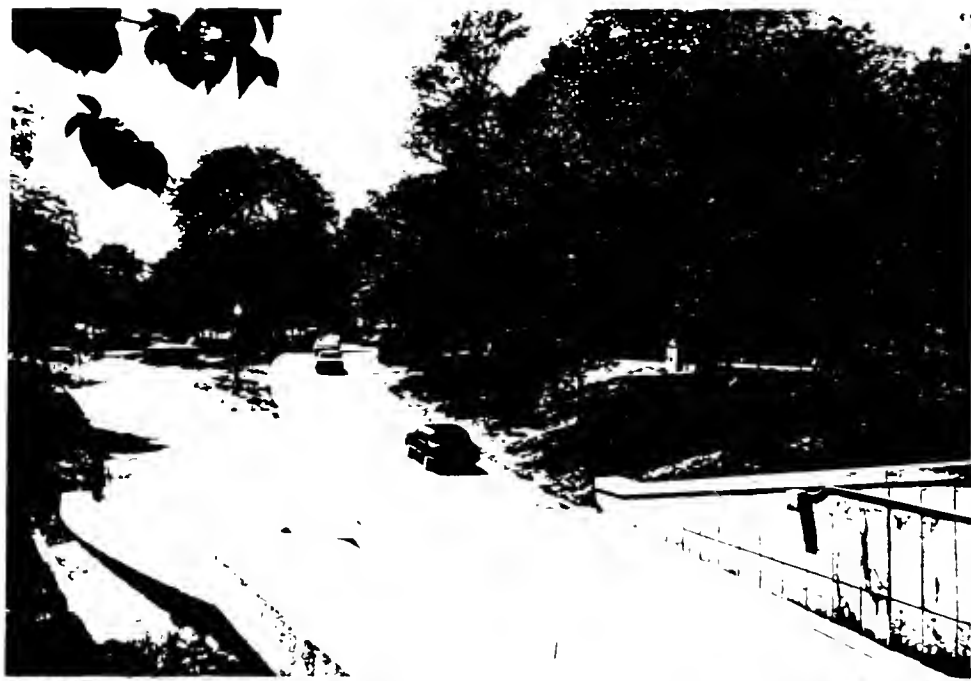
### Site Photograph 4

View down from  
Massachusetts Avenue  
overpass showing  
shrub plantings and  
poor grass.

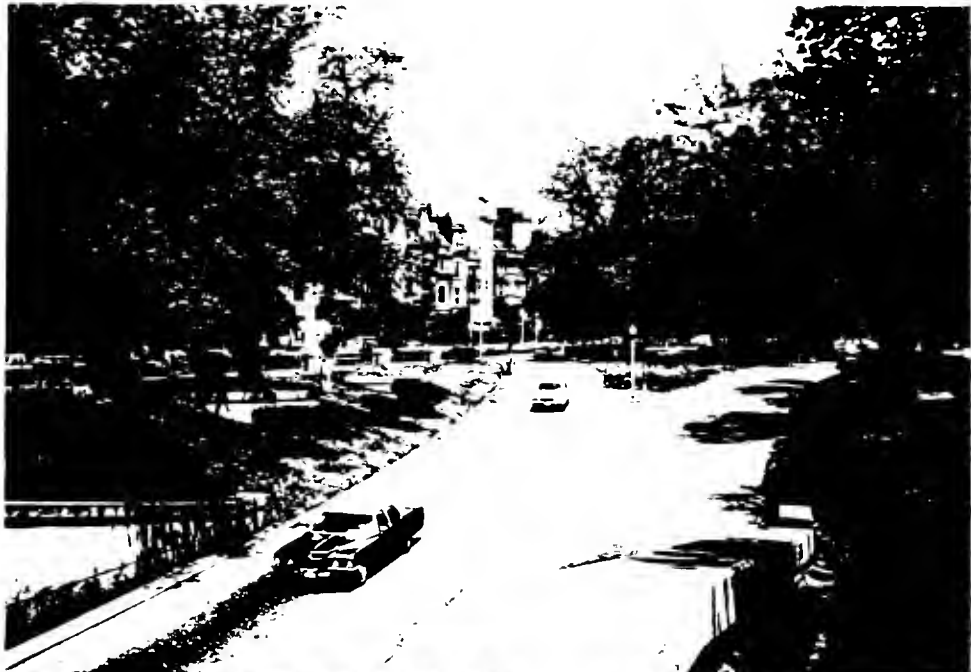
### Site Photograph 5

Shrubs old and distorted  
from over-pruning.  
Needs replanting.

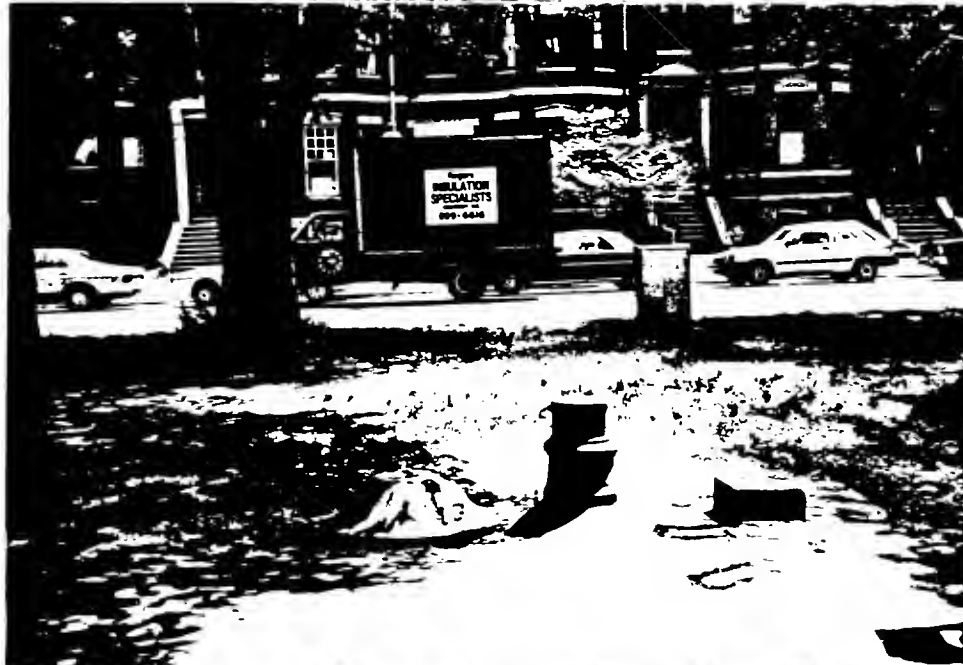
### Site Photograph 10

Granite drinking fountain in need of repair.

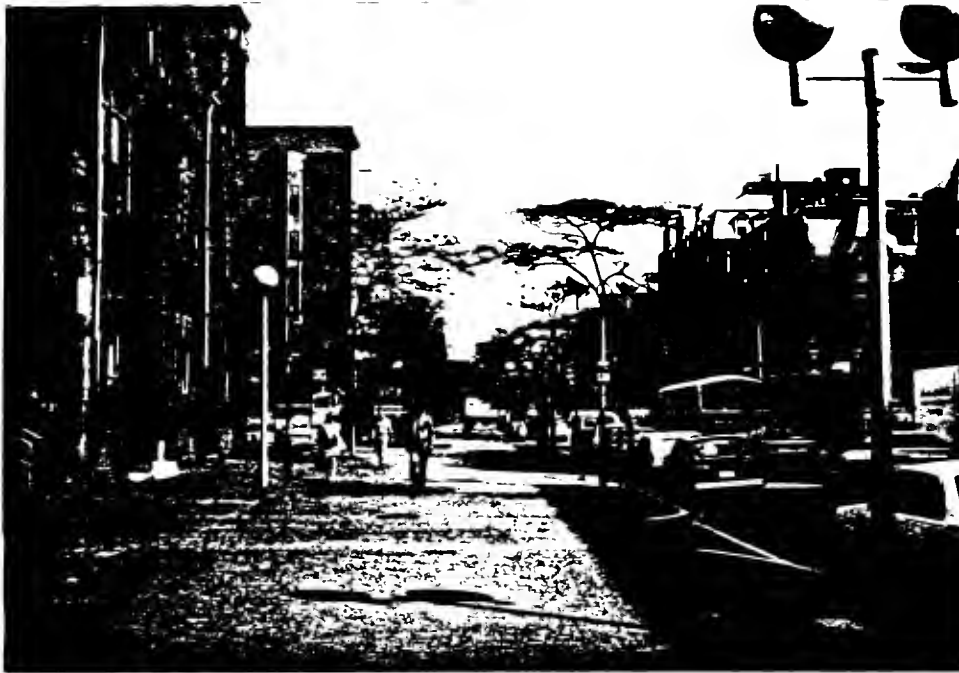
**Site Photograph 1**

View of block between Boylston and Newbury Streets. Note wide expanse of pavement in relationship to tree canopy. First tree on left typical condition of those to be removed - stunted and malformed.
